**Type:** Mémoire ou thèse / Dissertation or Thesis

MECHANICAL RESISTANCE OF CRACKED DAM MASS CONCRETE  
REPAIRED BY GROUTING: AN EXPERIMENTAL STUDY

DÉPARTEMENT DES GÉNIES CIVIL, GÉOLOGIQUE ET DES MINES  
ÉCOLE POLYTECHNIQUE DE MONTRÉAL

DÉCEMBRE 2012

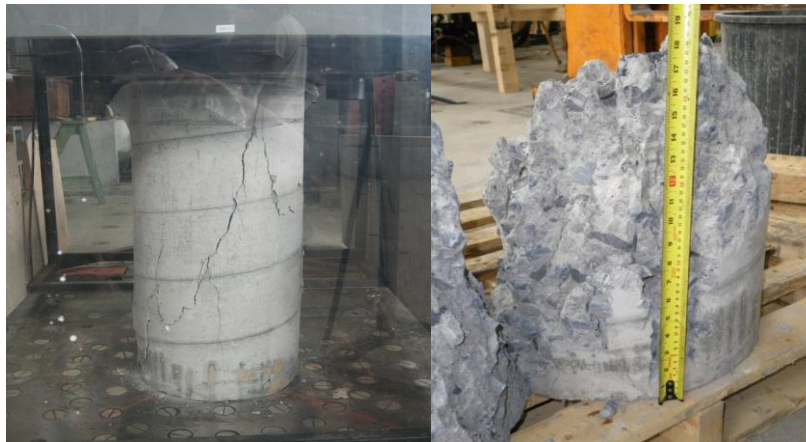
Figure 3-2: Mass concrete cylindrical specimen (400mm x 800mm)

Three cylinder specimens, seen in Figure 3-2, of 400 mm (16 in.) diameter and 800 mm (32 in.) in height, one from each batch of concrete, were poured into cardboard tubes. A modified version of ASTM C469 (to account for the larger specimens) was used to determine the compressive strength, modulus of elasticity, and Poisson's ratio of the concrete.<sup>17</sup> The size effect for the results of the compressive strength are negligible.<sup>18</sup>

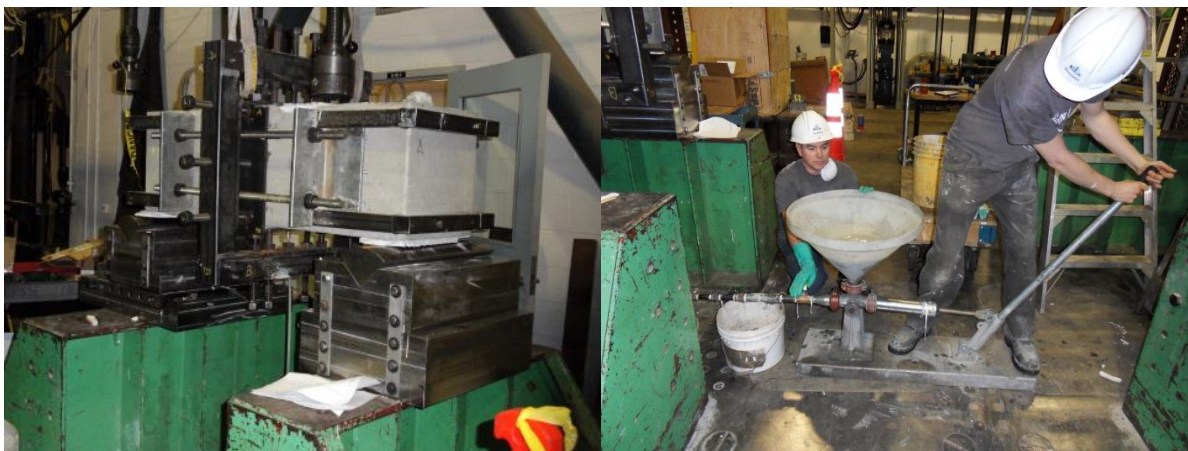
Figure 3-4: Injection and Injection Frame

The specimens were mounted with a support frame as seen in Figure 3-4. Upon failure of the specimen the crack between the two specimen halves was set to 2 mm (78.74 mil); this opening was selected so as not to impede the injection grout and to insure the best repair possible. This range of opening is representative of some of the openings at the crack mouth of BDJ. This was done with the help of 8 pairs of DEMEC points and by adjusting bolts on the 4 rods. The injection frame was installed on the specimens (A,B,C, and D) to allow the fracture to be repaired. The frame consisted of four 100 x 420 x 12 mm (4 x 16 x 1/2 in.) piece of pure gum that were held against the four sides of the specimen by steel plates. The plates were compressed onto the specimen by bolts attached to a steel frame that is installed around the specimen to seal the

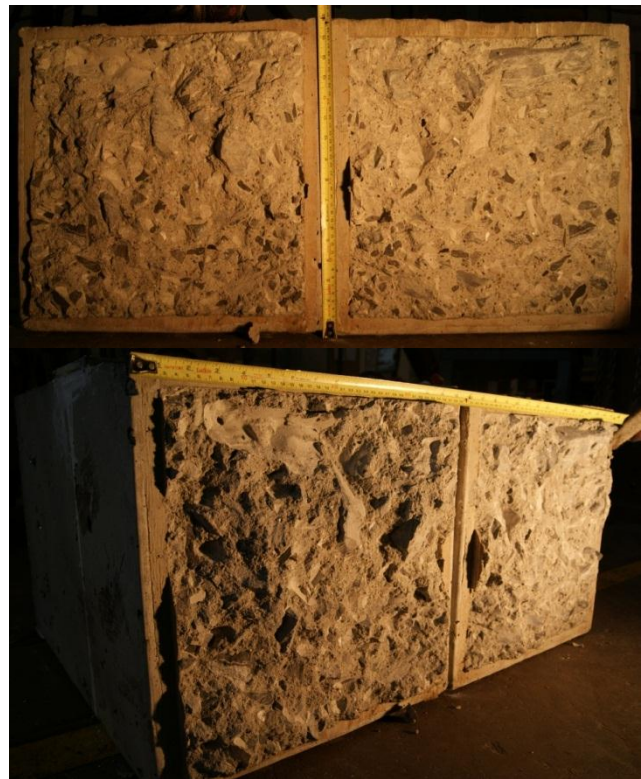
Figure 3-6: Modulus of Rupture Failure Plane (Specimen E)

The failure of both virgin and repaired specimens was brittle. The failure plane of virgin specimens, Figure 3-6, stayed in the concrete matrix and avoided most large aggregates, leaving them intact and protruding from the failure plane. The failure plane of repaired specimens followed the same path as for virgin specimens along the interface between the concrete and the injection grout. The failure plane propagated from one concrete surface through the grout to the other concrete surface depending on the positioning of the aggregate. The modulus of rupture of a virgin specimen, found in Table 3-7 and Figure 3-7, was 2.79 MPa, which is, 10% that of the compressive strength of the concrete.<sup>12</sup> After being repaired, the modulus of rupture was significantly reduced. For injection Grout I and Grout II, it was 0.55 MPa (80 ksi) and 0.95 MPa (138 ksi) respectively as seen in Table 3-7 and Figure 3-8. Multiple repairs had no noticeable effect on the modulus of rupture. The modulus of rupture of the repaired specimens was not reflective of the strength of the virgin concrete or the strength of the repair grout. The modulus of rupture exhibited distinct properties as a hybrid material being tributary of the adhesive strength between the grout and the concrete surface made of cement paste and aggregates. The increased modulus of rupture for a specimen repaired with a grout with a favourable or lower w/c ratio is not due to the grout being stronger, but due to the bond formed between the grout and the concrete. A lower water cement ratio increased bleeding and decreased density of grout as seen in Table 3-6. This in turn decreased the bond strength between the parent material and the injection grout.
