**Investigating the durability of Stellite hardfacing components used in the
power generation industry**

YUXIAO WU

Thèse présentée en vue de l'obtention du diplôme de *Philosophiae Doctor*

OCTOBRE 2019

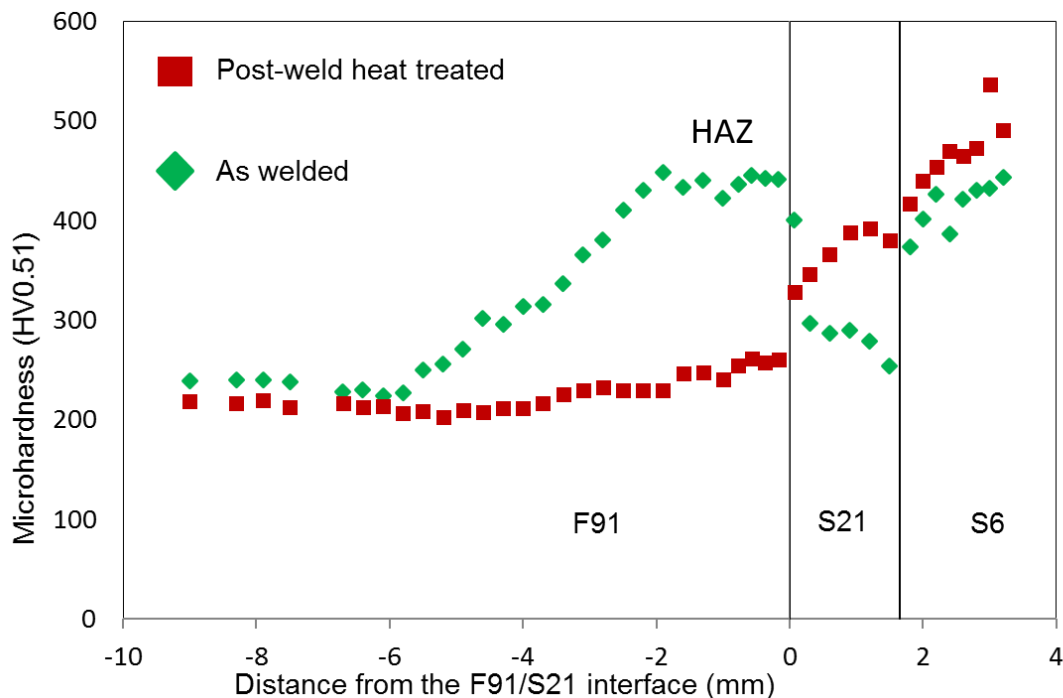
Figure 5.1: Hardness profiles of the S21 samples in the as-welded condition and after the PWHT.

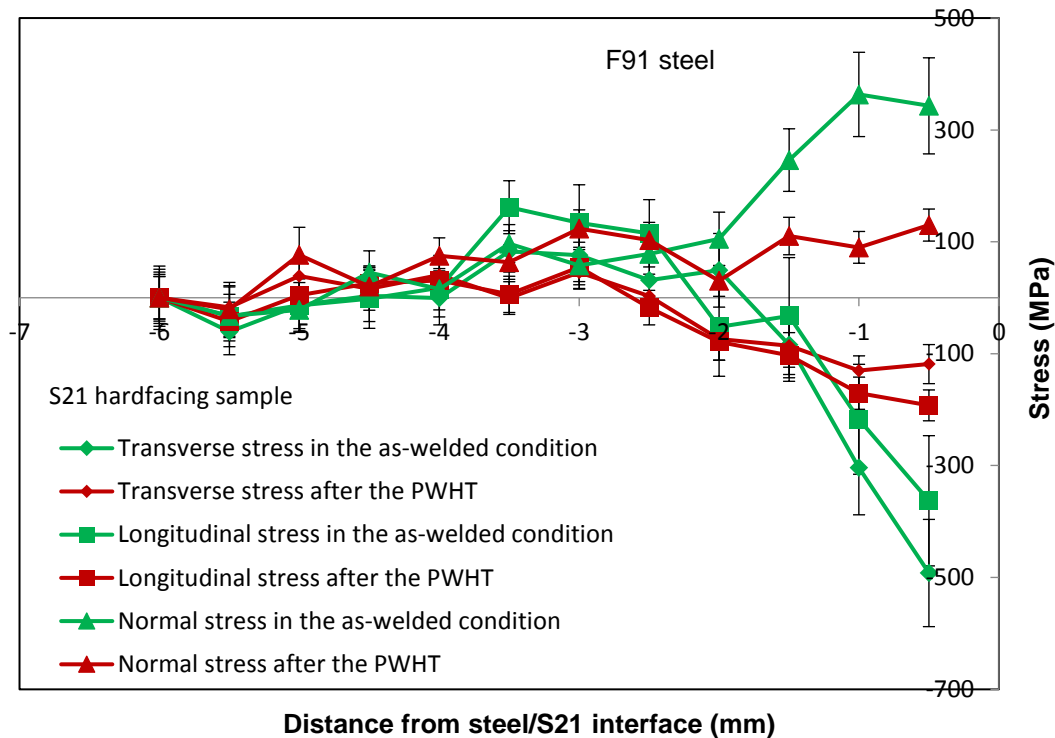
Figure 5.3: Residual stresses along three directions of the S21 samples in the as-welded condition and after the PWHT.

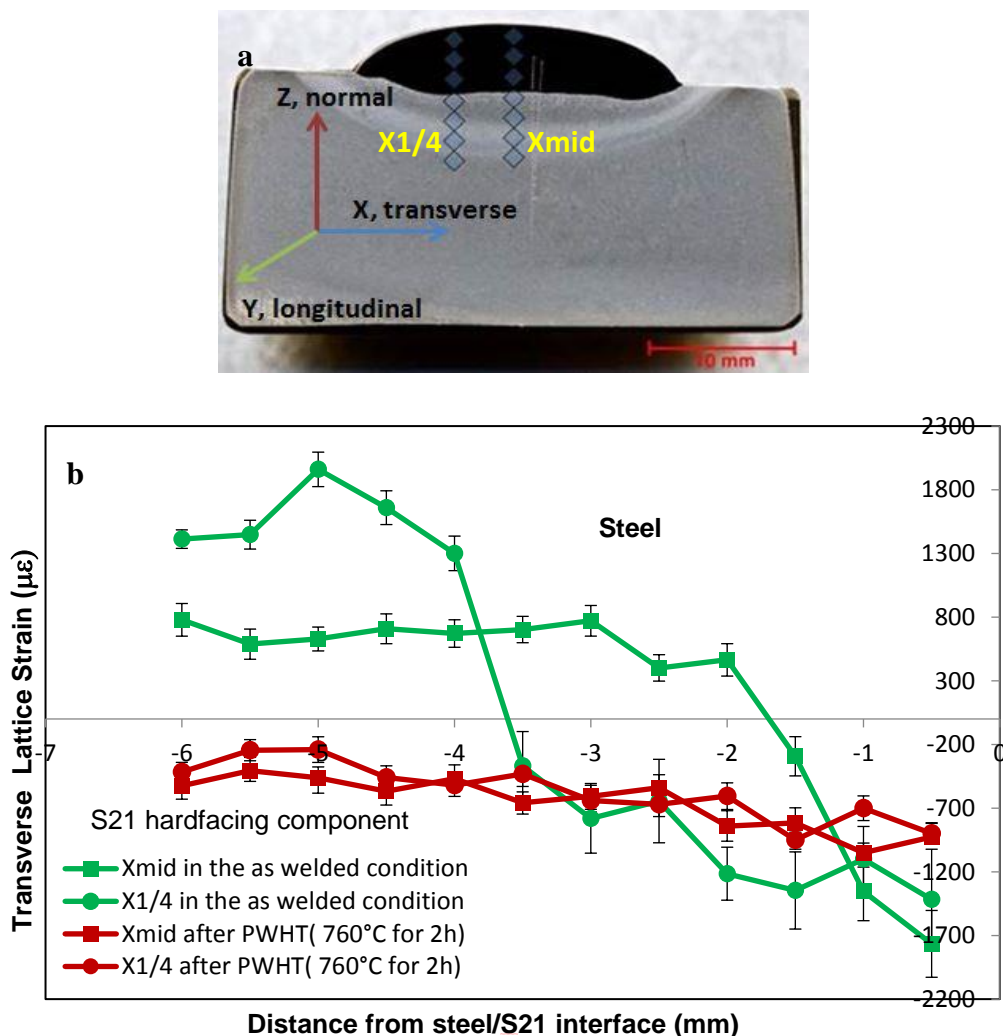
Figure 5.4: (a) A graph showing the measurements performed at the middle and a quarter of the weld bead and (b) transverse lattice strains across the weld in the as-welded condition and after the PWHT.

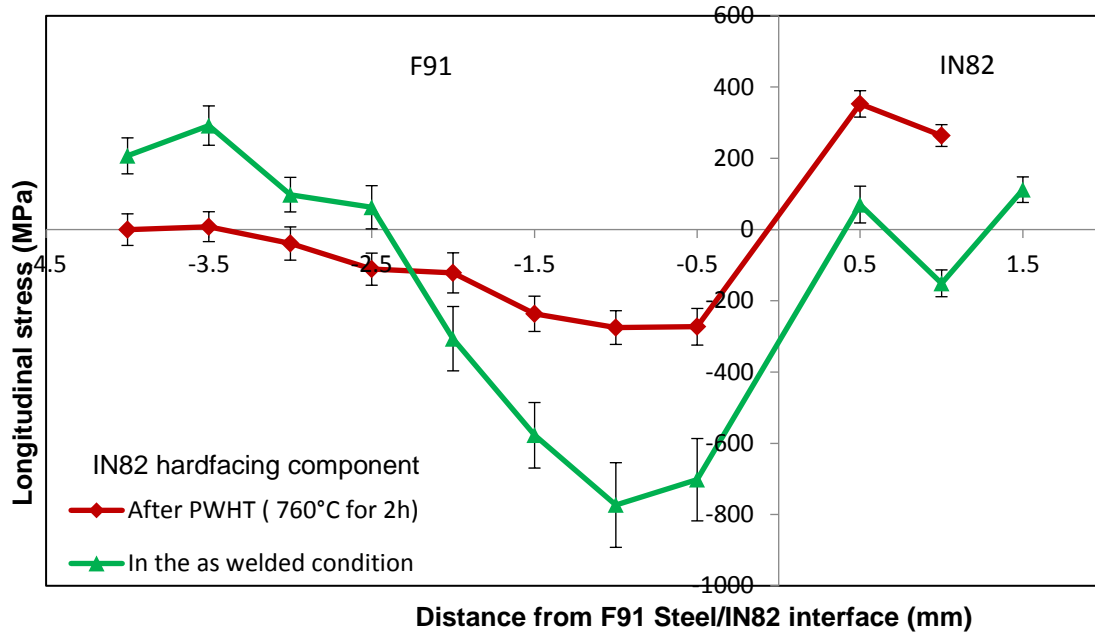
Figure 5.5: Longitudinal stress distribution of the IN82 samples in the as-welded condition and after the PWHT.

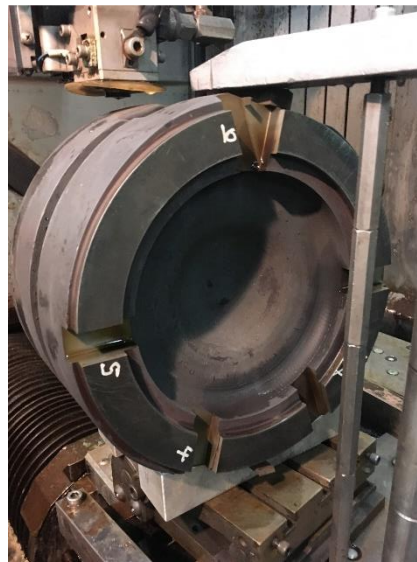
To transfer the knowledge obtained from the laboratory study to the industrial component, the delamination failure of an ex-service wedge gate valve, provided by a valve manufacturer, is investigated in this chapter. This ex-service wedge gate valve is shown in Figure 10.1. A part of this component was cut using wire electrical discharge machining. The sampling location is shown in Figure 10.2. A delamination crack was found in the sample, as shown in Figure 10.2.

Figure 10.1: An ex-service wedge gate valve.

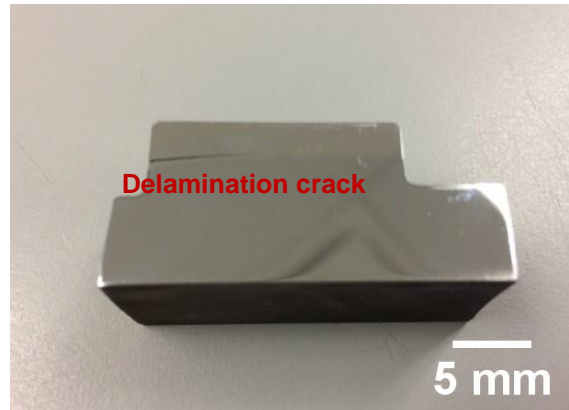
The sample was ground and polished, in which this delamination crack was observed on the cross-section shown in Figure 10.3. Figure 10.4a shows a full cross-section of this ex-service component: base material grade 91, buffer layer S21 and top layer S6. The rectangular zones shown

Figure 10.3: The cross-section of this sample after metallographic preparation.

in Figure 10.4a were further examined using SEM. The delamination crack went through the S21, not along the steel/S21 interface, as shown in Figure 10.4a. The S6 and S21 exhibited typical dendritic structure, as shown in Figure 10.4b, c, d and e. The most notable microstructural feature observed was the network of abundant veins starting at the steel/S21 interface, extending through the S21 bulk material, and stopping at the S21/S6 interface. These veins were up to nine μm in width. They appeared to follow grain boundaries.
