## Fluorescent thermal imaging of a non-insulated pancake coil wound from high temperature superconductor tape

We have wound a 157-turn, non-insulated pancake coil with an outer diameter of 85 mm and we cooled it down to 77 K with a combination of conduction and gas cooling. Using high-speed fluorescent thermal imaging in combination with electrical measurements we have investigated the coil under load, including various ramping tests and over-current experiments. We have found that the coil does not heat up measurably when being ramped to below its critical current. Two over-current experiments are presented, where in one case the coil recovered by itself and in another case a thermal runaway occurred. We have recorded heating in the bulk of the windings due to local defects, however the coil remained cryostable even during some over-critical conditions and heated only to about 82–85 K at certain positions. A thermal runaway was observed at the center, where the highest magnetic field and a resistive joint create a natural defect. The maximum temperature,  $\sim 100$  K, was reached only in the few innermost windings around the coil former.

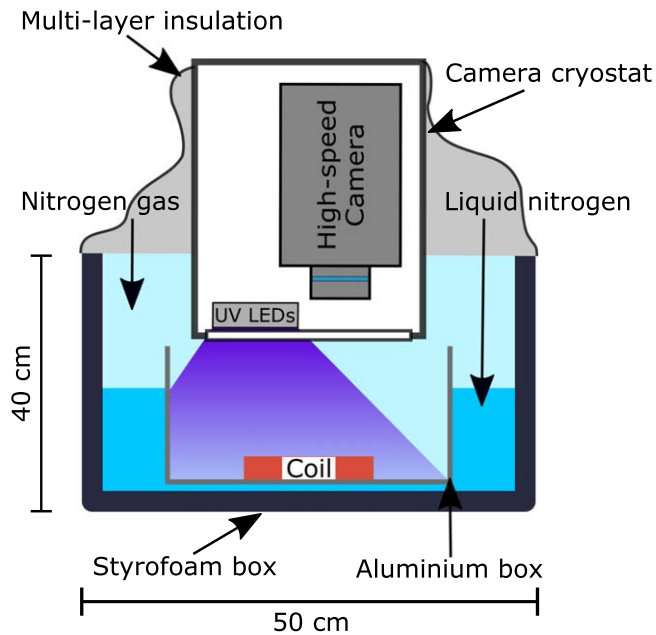
**Figure 1.** Cross-section view of the experimental setup.

To avoid complex and expensive vacuum and cryocooler setups with optical windows—and since the aim was to test the coil only at 77 K—a simple, two-component cryostat was constructed, as shown in figure 1. An aluminum container was placed inside a larger polystyrene container, and the space between the two was filled up with liquid nitrogen. The coil was placed into the aluminum box and a good thermal

contact was made between the two with the help of a thin layer of thermal paste. This allowed the coil to be conduction-cooled to 77 K via the aluminum container's walls. The remaining space in the containers was filled with evaporated, cold nitrogen gas, providing a cold and clear atmosphere, ideal for optical measurements. The high-speed camera was then positioned above the setup and lowered close to the coil inside a separate optical cryostat that kept the camera at room temperature. The UV excitation light was also placed in the camera's cryostat. The setup was finally surrounded by multi-layer insulation from the top to shield the sample from radiation heat sources, and also to block out ambient light. The steady boil-off of the liquid nitrogen provided a continuous flow of nitrogen gas, preventing moisture and air from entering the experimental assembly and building fog. The result was a conduction-cooled NI-coil in a pure, cold, nitrogen atmosphere. The high-speed camera, despite having been used in the past at several thousand frames per second (fps) to measure quenches in single HTS tapes [14], was used here at the slowest speed setting of 50 fps, which was found sufficient for measuring the heating in the NI-coil. This allowed a maximum recording time of about 10–12 min per experiment.

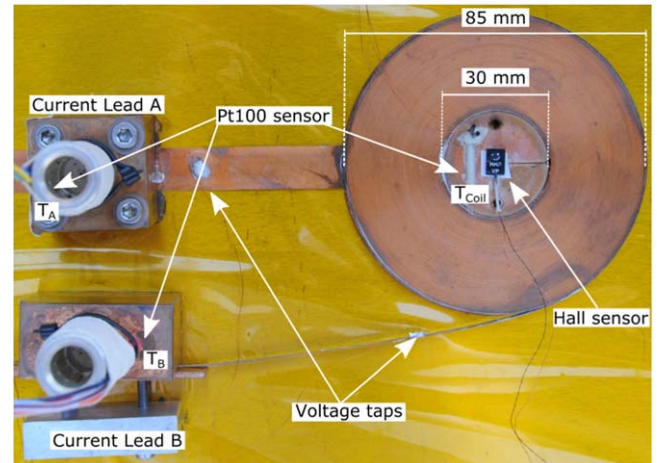
**Figure 2.** HTS non-insulated coil placed at the bottom of an aluminum box. A Kapton sheet served as electrical insulation in between.

A picture of the coil and the electrical instrumentation is shown in figure 2. The magnetic field was measured with a Hall sensor located at the center of the coil. The voltage was measured across two superconducting current leads. However, this path includes the resistive soldered joint between the 12 mm HTS current lead and the coil former, as well as between the coil former and the first turn. To establish the time required for reaching thermal stability inside the measurement assembly during cooling as well as to monitor any possible temperature rise during the measurements, temperatures were measured at three positions using Pt100 sensors. Each of the current contacts had an embedded sensor, labeled

$T_A$  and  $T_B$ , respectively. In the measurements it was found, however, that these remained close to 77 K and were hence not plotted. The third sensor  $T_{\text{Coil}}$  was used for measuring the temperature inside the coil former. The coil temperature sensor allowed monitoring the temperature rise of the copper bobbin in real-time during the measurement and it is plotted in the supplementary video, available online at [stacks.iop.org/SUST/32/105006/mmedia](https://stacks.iop.org/SUST/32/105006/mmedia). The current was measured with a shunt resistor inserted in the circuit. This resulted in seven data acquisition channels, which were recorded using an NI-USB 6289 DAQ, at a rate of 1000 samples per second, and several Dataforth and Dewetron pre-amplifiers for acquiring low voltages. In parallel, the coil voltage was also measured with a nanovoltmeter at a slower rate of 1 sample per second for higher accuracy.

<sup>3</sup> The online supplementary video shows the thermal imaging as well as the electrical signals. The latter includes the current, magnetic field and voltage across the coil as well as the temperature measured by the Pt100 sensor  $T_{\text{Coil}}$  inside the center copper former as shown in figure 2.

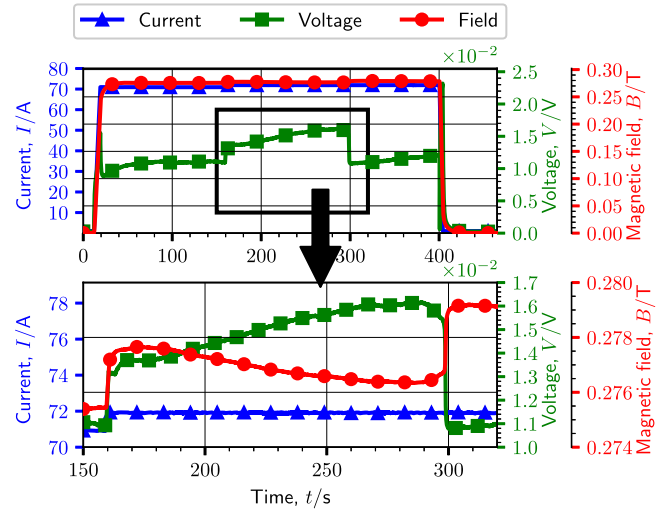
**Figure 3.** Electrical measurements of the coil during the 72 A over-current test. The bottom plot shows a zoomed area marked by the black rectangle. Note that the axes ranges are changed on the zoomed plot.

The coil current was first ramped up to 71 A at a rate of  $10 \text{ A s}^{-1}$  and the voltage was monitored, as shown in figure 3. It eventually stabilized and so the current was increased to 72 A, this time at a slower  $1 \text{ A s}^{-1}$  rate, as shown at time 160 s.

At this current level, a slow yet steady voltage shift was observed, and the coil was held at this level.

Since the magnetic field also reduced with the increasing voltage, the current must have been changing from the spiral to the radial path. This is also supported by the quasi-linear voltage rise observed, as expected with increasingly more current flowing through a resistor. In figure 4(a) one can see that the outer turns of the coil are initially at a higher temperature, due to slightly worse cooling at the outer edge of the coil compared to the inner former as well as due to the over-current regime. At the same time, distinct heating is visible in the form of circles with varying width, as can be seen in figures 4(a) and (b) highlighted by the white arrows. This indicates that at particular locations in the coil, the current flows through the turn-to-turn contact resistance and generate losses. At about 298 s into the measurement, the voltage dropped and the magnetic field increased sharply, indicating that the current reverted back into the spiral path abruptly. Simultaneously, the center windings of the coil have heated up, as indicated by the white arrows in figure 4(c), where the ring-like hot areas have been replaced by an uniformly warmer zone, mostly on the left hand side of the coil. Hence the current flowing through the turn-to-turn contact resistances of the coil can be seen on the thermal image as heating over possibly several turns, which is most likely a function of the cooling performance and the distribution of local fluctuations of  $I_c$  along the length of the wound conductor.

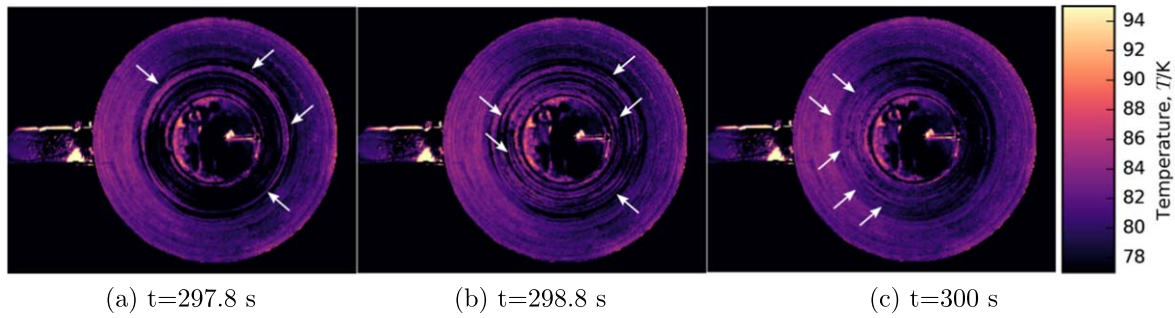
**Figure 4.** Thermal images of the coil during the 72 A over-current test showing different time points just before and right after the ‘self-recovery’. The white arrows indicate features, as described in the text.

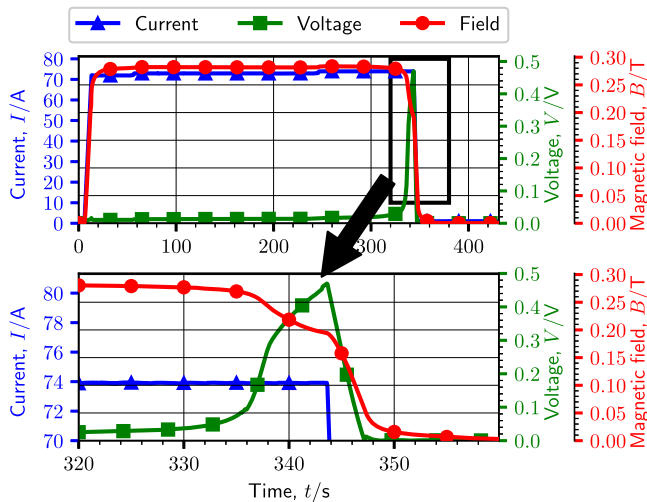
**Figure 5.** Electrical measurements of the coil during the 74 A over-current test. The bottom plot shows a zoomed area marked by the black rectangle.

To reproduce previous results and observe the same behavior again, the coil current was ramped up in a subsequent measurement directly to 72 A at a rate of  $10 \text{ A s}^{-1}$ , as shown in figure 5. However, in this case, no voltage drift was observed. The current was therefore ramped up to 73 A, and finally 74 A, at a slower  $1 \text{ A s}^{-1}$  rate, where the coil voltage became

unstable and started increasing once again. Over the course of two minutes at a steady current of 74 A, the coil voltage rose up continuously until its final value of 0.47 V, at which the coil current was ramped down quickly. The field started decaying with the developing voltage, indicating a slow current transfer into a radial path. Then, after 336 s, a much sharper voltage rise and accompanying field drop became visible, likely due to (some of) the HTS tapes becoming resistive. Figure 6 shows excerpts of the thermal imaging recording at three different time instants. In figure 6(a), one can see that the outside of the coil is again at a higher temperature, however still cryostable. Warmer zones are still visible around the center and middle layer of the coil (shown by the white arrows), indicating heating due to currents flowing through the turn-to-turn contact resistances. Figure 6(b) shows that the middle layers seem to have mostly cooled down, and at the same time—due to the superconducting transition—the innermost windings started heating up. At the bottom of the image, where the outer current lead arrives at the coil, a hot spot is also visible. Then in figure 6(c), just before the current was ramped down to protect the coil, the hottest temperature of around 100 K was reached at the few innermost windings of the coil. When looking at the dynamic development (see the online

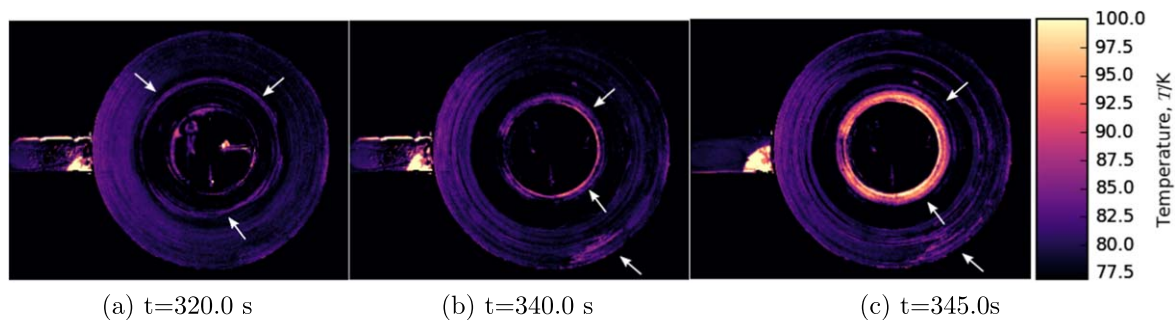
**Figure 6.** Thermal images of the coil during the 74 A over-current test showing different time points just before and at the moment of thermal runaway and ramping down. The white arrows indicate features, as described in the text.

supplementary video<sup>3</sup>) one can identify a stage between figures 6(a) and (b). Between these times the middle turns of the coil actually cooled down, and when the voltage continued to rise, the central windings started heating up instead. A possible explanation is that when the coil voltage is low, only the ‘major’ defects in the coil can be bypassed. However, at higher voltages, more current can be forced through the turn-to-turn contact resistances, thereby reducing the current in the superconductor as well as the local heating. Due to the fact that the energy is dissipated over a larger volume, this could then manifest in a form of a local cooling effect. Then in figure 6(c), the center windings see the combined effect of superconducting to resistive transition of the HTS due to the reduced temperature margin and high magnetic field, combined with the current bypass and joule heating due to the resistive joints. To check for damages, after each measurement, the coil resistance was measured and compared with its previous values. At the end, a second  $I_c$  measurement was also done and no degradation was observed.
