**METHODOLOGY FOR
RISK ASSESSMENT IN NATURAL HAZARDS
(FOCUS ON LANDSLIDES)**

DÉPARTEMENT DE GÉNIE CIVIL
ÉCOLE POLYTECHNIQUE DE MONTRÉAL

MÉMOIRE PRÉSENTÉ EN VUE DE L'OBTENTION
DU DIPLÔME DE MAÎTRISE ÈS SCIENCES APPLIQUÉES
(GÉNIE CIVIL)

DÉCEMBRE 1997

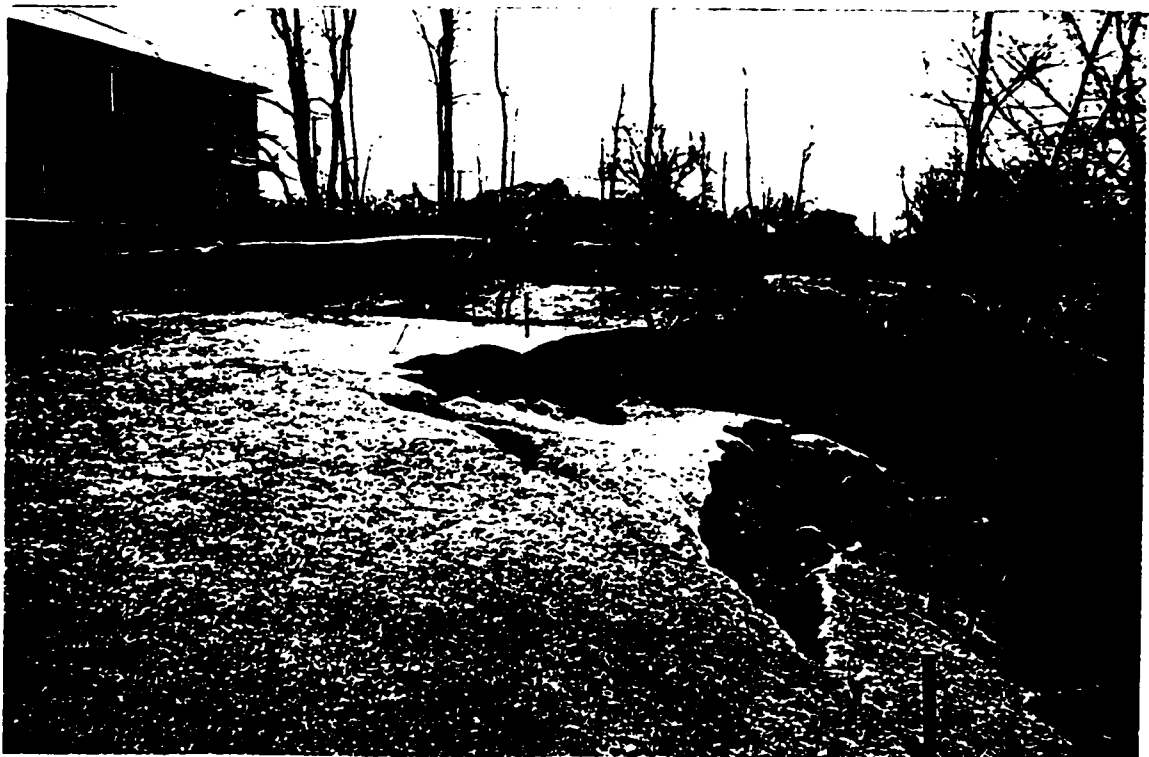
Fig. 6-2 Landslide is a continuous problem in Repentigny

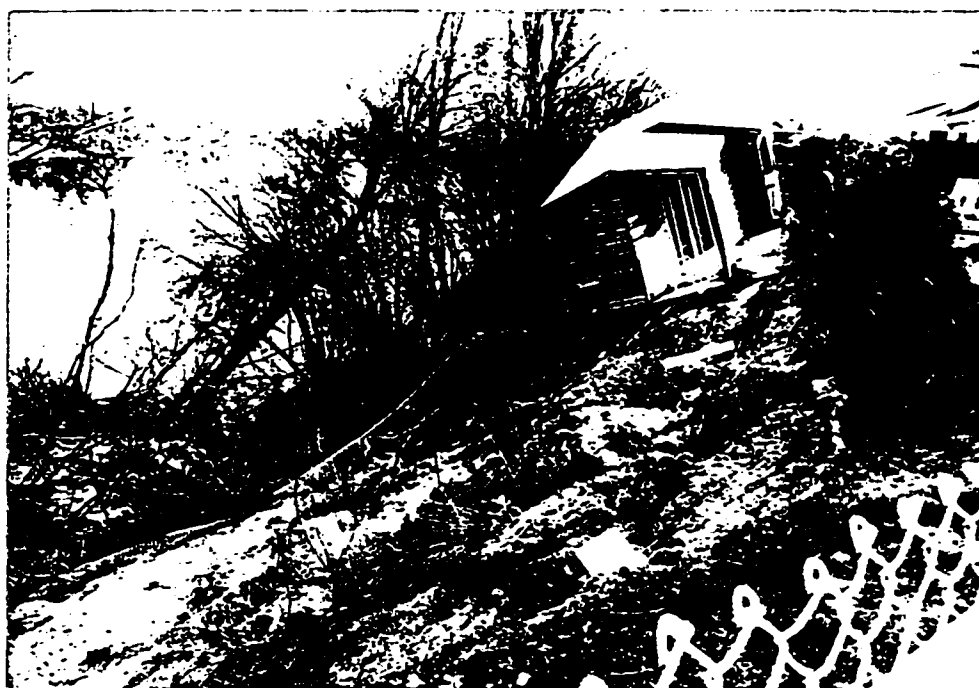
Fig. 6-3 Effect of latest landslide on residential buildings
