Journal of Building Engineering 95 (2024) 110167

Crossflow microsand filtration in cooling tower systems to control fouling in heat exchanger devices

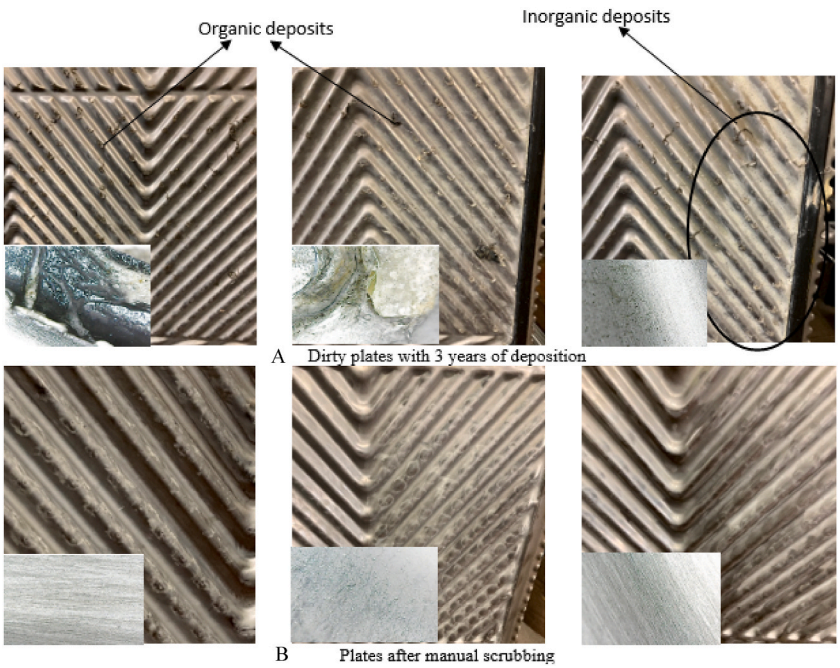
A visual examination of the in-situ HX plates exposed to the CT water was performed before (Fig. 4a) and after cleaning (Fig. 4b). Before cleaning, the depositions appeared to be mainly organic and located on the upper part of the HX plates. All the organic and loose deposits were scrubbed, washed, and collected. White deposits associated with scaling located on the edges of the plates could not be collected through manual scrubbing. Plates were further cleaned by mechanical scrubbing and pressure washing.

Fig. 4. Selected plates before cleaning (A), clean plates after mechanical scrubbing and pressure washing (B); Pictures on the bottom left of each figure are the 500X microscopic images of deposits on the HX plates.
