Titre: Study of the fractography and micromechanisms of near-threshold
Title: fatigue cracking and transgranular stress-corrosion cracking

"STUDY OF THE FRACTOGRAPHY AND MICROMECHANISMS OF
NEAR-THRESHOLD FATIGUE CRACKING AND TRANSGRANULAR
STRESS-CORROSION CRACKING"

THÈSE PRÉSENTÉE EN VUE DE L'OBTENTION
DU GRADE DE PHILOSOPHIAE DOCTOR (Ph.D.)
(GÉNIE MÉTALLURGIQUE)

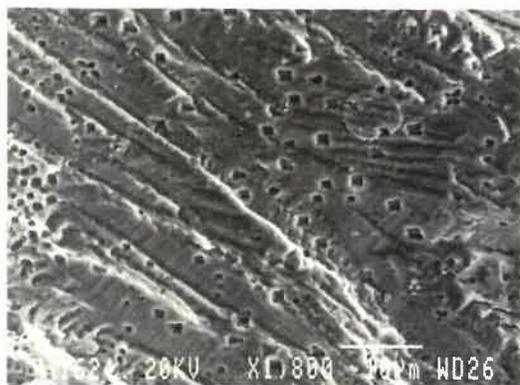
Fig. 3.20

Fig. 3.20: {100} <110> cracking crystallography observed for $da/dN \approx 10^{-6}$ mm/cycle in 8% Mn-8% Al-2% Ni (AC condition) bronze tested in air.

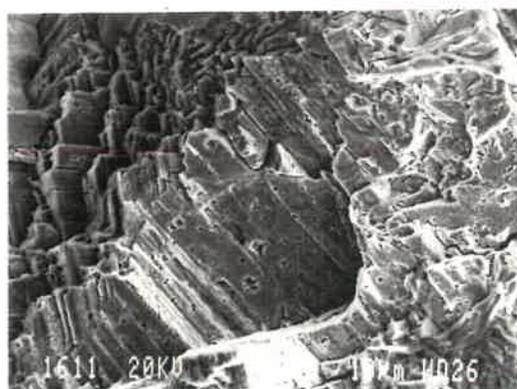
Fig. 3.22: Stair-like facets observed for ultra-low crack growth rates ($da/dN \approx 10^{-8}$ mm/cycle) in 8% Mn-8% Al-2% Ni bronze tested in air (HT₁ condition).

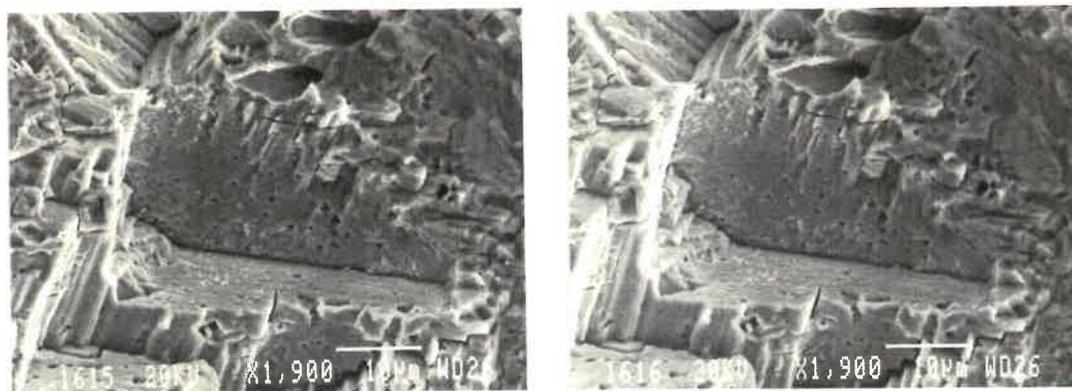
Fig 3.23: Two relatively large {111} facets observed for ultra-low crack growth rates ($da/dN \approx 10^{-8}$ mm/cycle) in 8% Mn-8% Al-2% Ni bronze (HT₁ condition tested in air).

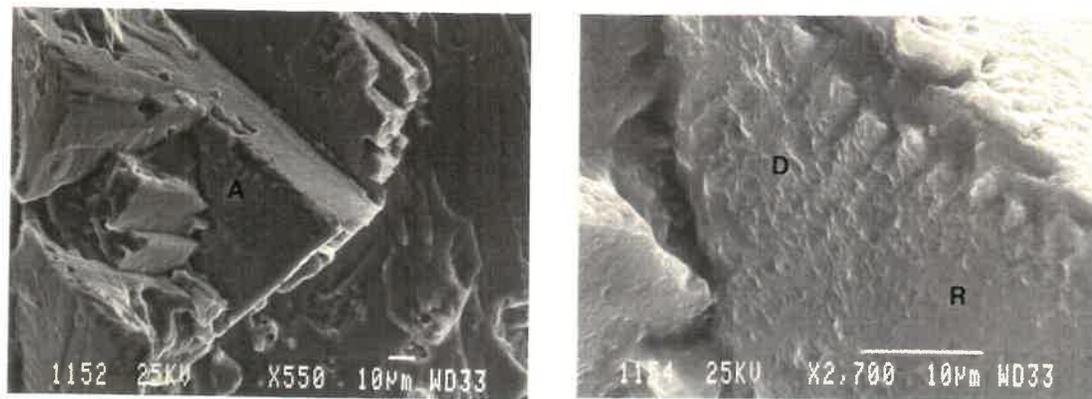
Fig. 3.35: Pyramid-like large $\{111\}$ facets presented on an unetched fracture surface at ultra-low crack rates in the test in vacuum (a) aspects at low magnification; (b) details of facets A, showing rubbing appearance at region R; (c) details at region D of facet A.

Fig. 3.35 (a) presents three $\{111\}$ pyramidal facets observed on an unetched fracture surface for a very low crack growth rate ($da/dN \approx 10^{-8}$ mm/cycle) in a test

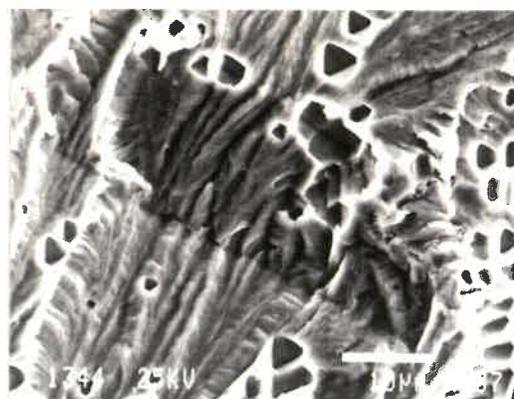
Fig. 4.8: More complex fractographic aspect observed at intermediate K, presenting numerous microfacets not parallel to the average orientation of the fracture plane.

As K increased to intermediate values (15-20 MPa $m^{1/2}$), the fracture facets generally became rougher. Etch-pitting indicated that cracking still produced primary facets of approximately $\{100\}$ average orientation. The rougher fracture facets indicated larger-scale and more apparent deviation of the microscopic crack path from the average orientation of the primary facets observed at low K. The average crack plane in the portion of Fig. 4.8 below the annealing twin (i.e. lower left) is seen to consist of two sets of facets quite steeply inclined with respect to each other. Each of these sets can be seen to consist of much finer sheet-like microfacets. Stereofractographs (Fig. 4.9) taken in the portion R of Fig. 4.8

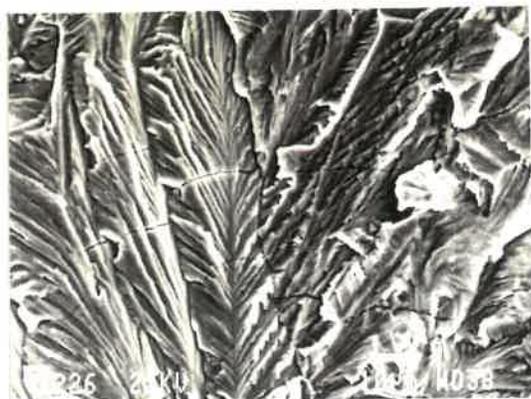
Fig. 4.16

Fig. 4.16: Fractographic features produced in the high K portion of stage II of the $\log da/dN$ - $\log K$ curve. Secondary cracks permit one to identify intermediate positions of the crack front.

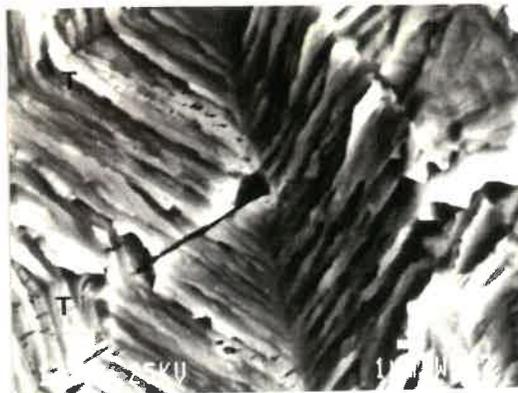
Fig. 4.17

Fig. 4.17: Herring-bone pattern of river lines observed at high K.

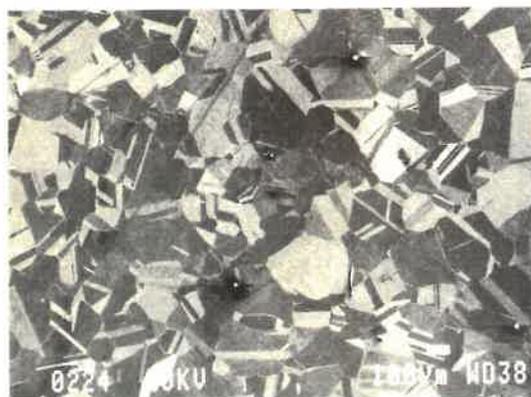
Fig. 5.1: Microstructure of α -brass employed.

The microstructure of the material after annealing is given in Fig. 5.1. The etching solution used for displaying the microstructure was 15 ml of HCl (Conc.), 5 g of FeCl_3 and 60 ml of double distilled H_2O . The etch time was approximately 30 seconds.

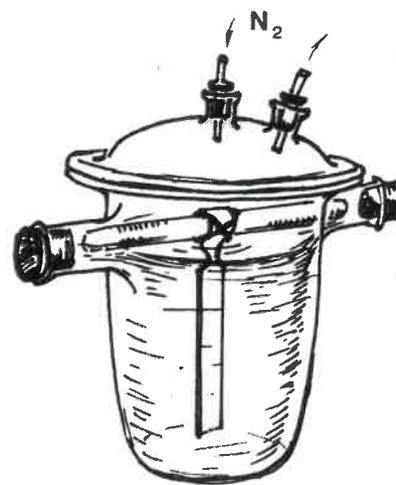
Fig. 5.20: Schematic of the experimental arrangement for test 20 in table 5.4

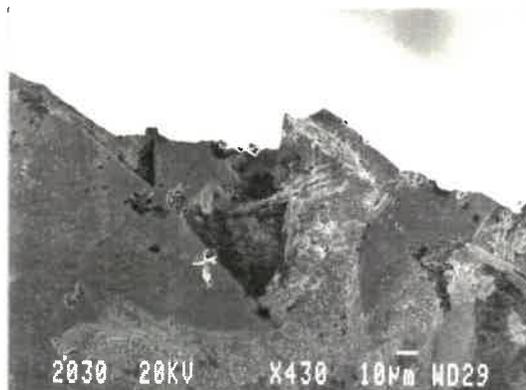
Fig. 6.26

Fig. 6.26: Profile of the fracture surface of the HT2 propeller specimen tested in the NaCl solution, showing the crack path in the β phase tended to be crystallographic with the crack orientation deviating on crossing $\alpha - \beta$ interfaces, $da/dN \approx 1 \times 10^{-5}$ mm/cycle.
