Titre: Recycled carbon black/high-density polyethylene composite from waste tires: manufacturing, testing, and aging characterization

Auteurs: Catherine Billotte, Laurence Romana, Anny Flory, Serge Kaliaguine, & Edu Ruiz

Date: 2024

Type: Article de revue / Article

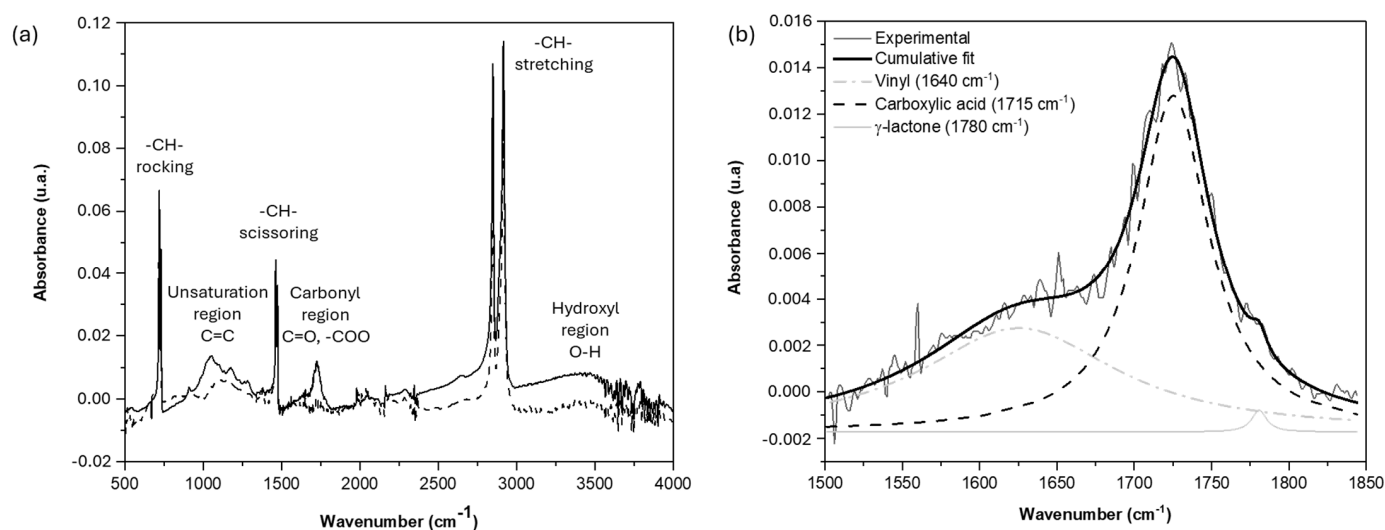
Figure 12. IR spectra of weathered HDPE sample at 85 days: (a) global experimental curve of aged (black line) and non-aged (black dash) samples and (b) zoom on the carbonyl region of the aged sample and peak deconvolution. Experimental curve (black line); cumulative fit (thick black line); vinyl (gray dash dot); carboxylic acid/ketone (black dash); γ -lactone (gray line).

A typical FTIR spectrum of an 85-day-aged HDPE is shown in Figure 12a. Three main regions are connected to the oxidation process: the C=C bands (700 cm^{-1} to 1300 cm^{-1});

the C=O bands (1500 cm^{-1} to 1850 cm^{-1}); and the O-H bands (3200 cm^{-1} to 3600 cm^{-1}). Table 1 summarizes the FTIR absorption spectrum of the HDPE and its main oxidation products usually reported in literature [25,34,45–48]. In this work we have focused on the C=O band region only, which is the band where the oxidation first appears in HDPE [25,34] and remains predominant in this work. An enlarged view of the carbonyl oxidized region between $1500\text{--}1850\text{ cm}^{-1}$ wavelength is illustrated in Figure 12b. The band deconvolution shows three main peaks: carboxylic acid/ketone around 1715 cm^{-1} , γ -lactone at 1780 cm^{-1} and vinyl at 1640 cm^{-1} . These peaks are characteristic of HDPE polymer oxidation products, and the cumulative band (red curve) fits well with the experimental data (black curve). The carbonyl region is the most apparent for both the virgin HDPE and composite R6, and more specifically the band C=O at 1715 cm^{-1} . The other absorption bands are less well defined, especially for R6, where they are sometimes even confused in the baseline. The baseline indeed presents variations in absorbance of 0.0076 unity of absorbance (u.a.) in the initial FTIR spectra of both HDPE and R6 inside the carbonyl region ($1500\text{--}1850\text{ cm}^{-1}$). Absorbance bands below this value are therefore considered as signal noise. Oxidation was quantitatively analyzed using the carbonyl index (CI) using the SAUB method [49] and defined as follows:
